# National Transportation Safety Board

**DCA22WA102**

## **COCKPIT VOICE AND FLIGHT DATA RECORDER**

Location: Wuzhou, China  
Date: March 21, 2022  
Time: 0630 UTC  
Airplane: Boeing 737-800, China Eastern Airlines, Registration B-1791

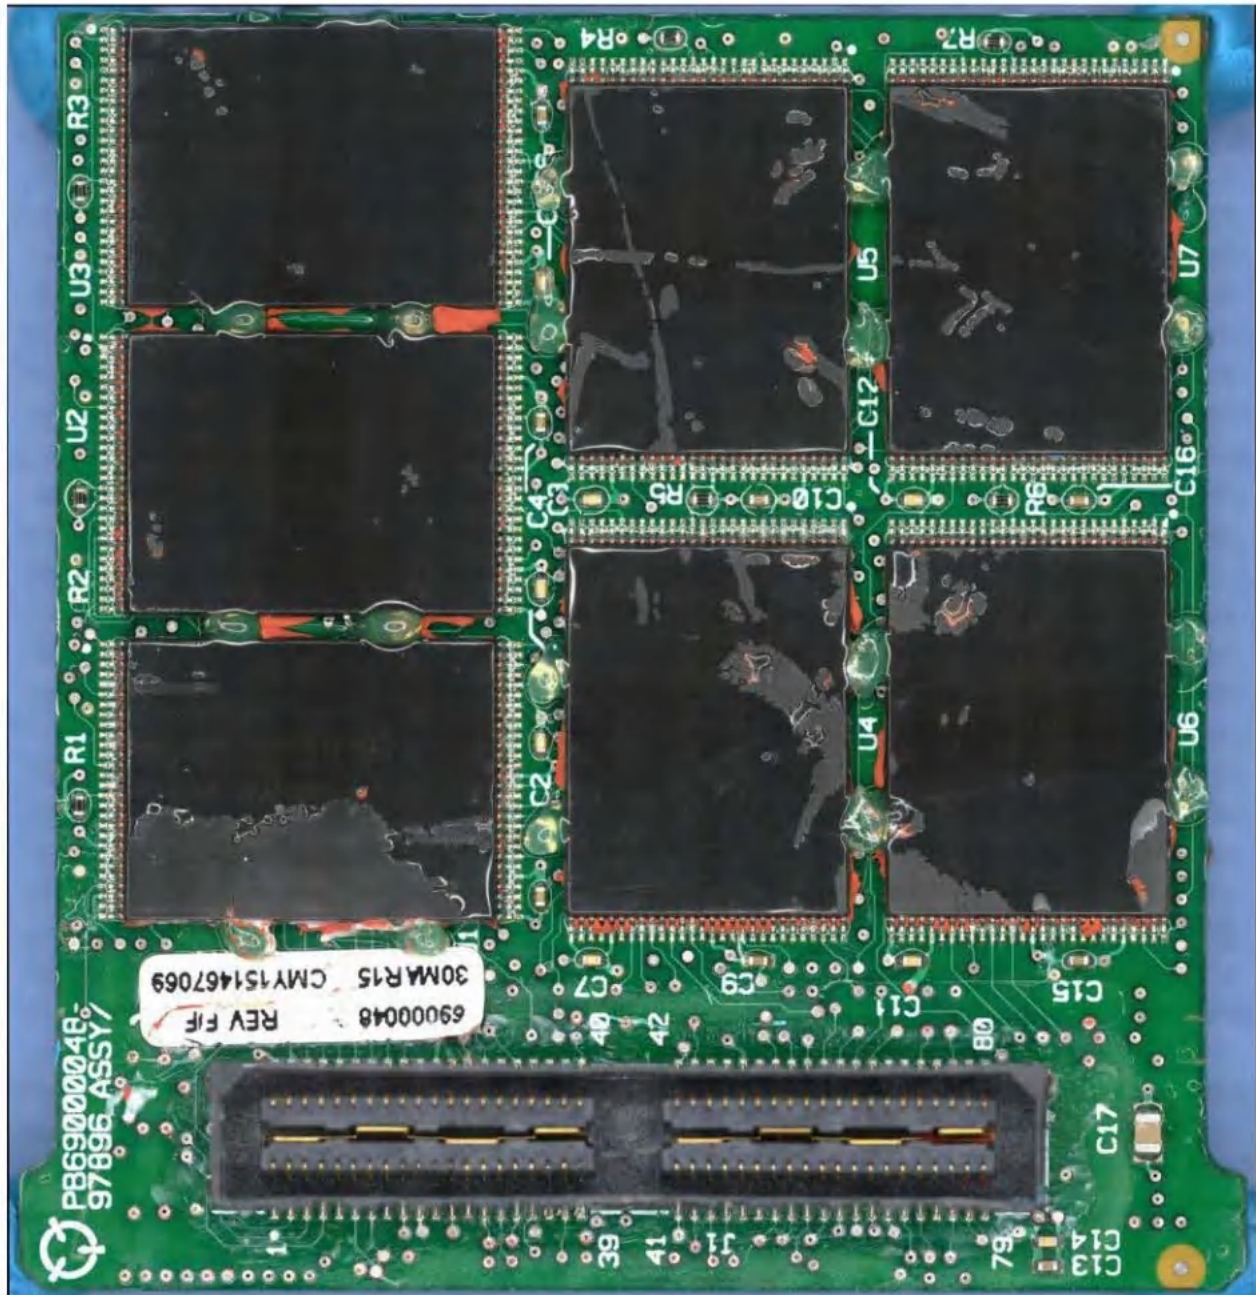
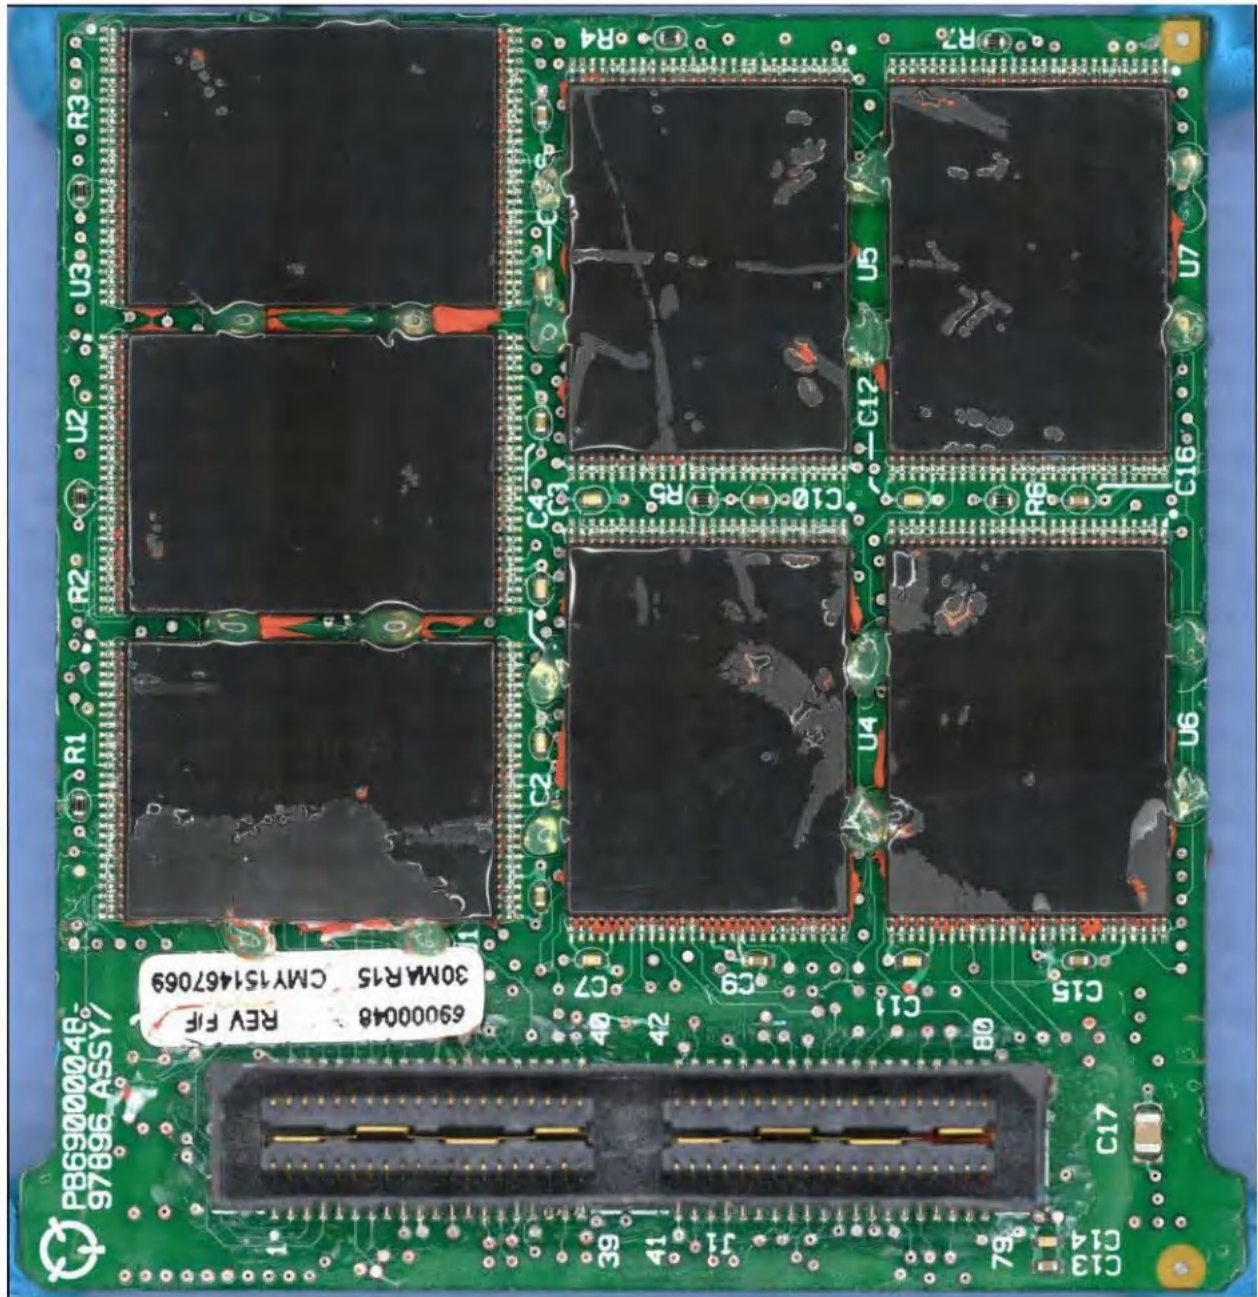
Figure 1.CVR memory module board,connector side.

The CVR memory module was presented to the NTSB for microscopic inspection.Figure 1 shows the connector side of the board and Figure 2 shows the opposite side.Both sides have FLASH memory chips containing data.Preliminary findings showed the board to have substantial damage to the connector area of the device.Numerous solder pads attaching the connector to the board and providing the electrical signal path to the data chips were found bent or completely dislodged from the board.(See Attachment 1,CMM Recovery Report,for additional details and specifics of connector damage).The damaged pins corresponded to chip data lines and address lines.This damage would be significant to the download and is consistent with the audio artifacts present in the data.Damage to chip data lines would manifest as quantization error-type digital noise and damage to chip address lines would manifest as stuttering,echoing,and repeating-type noises.

进一步检查还发现，连接器自身的塑料部分已轻微偏离其正常状态发生变形。沿电路板末端的长边亦存在类似情况。

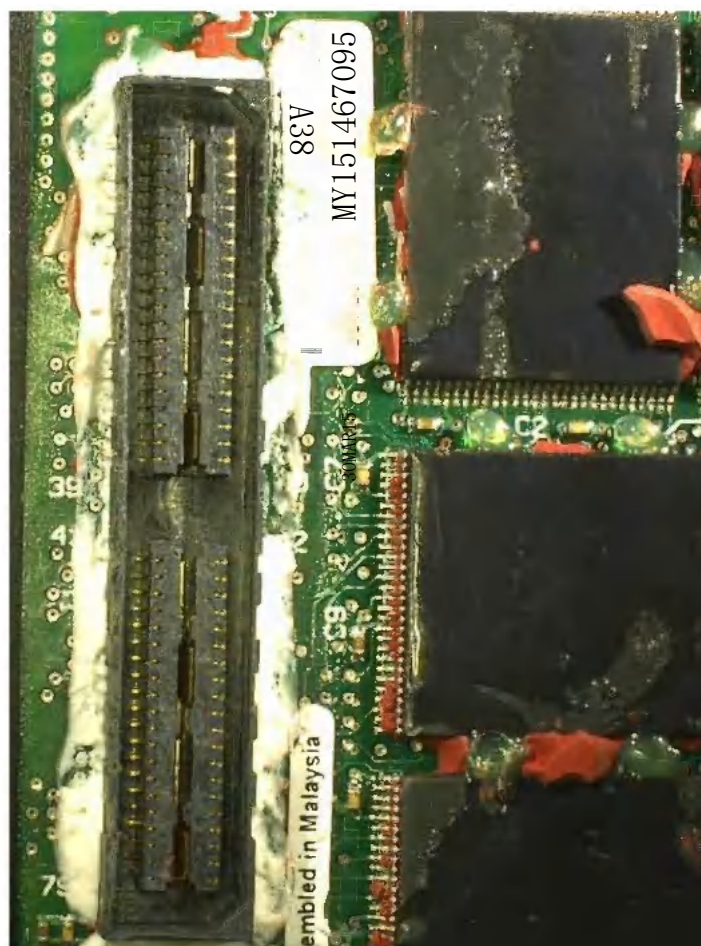
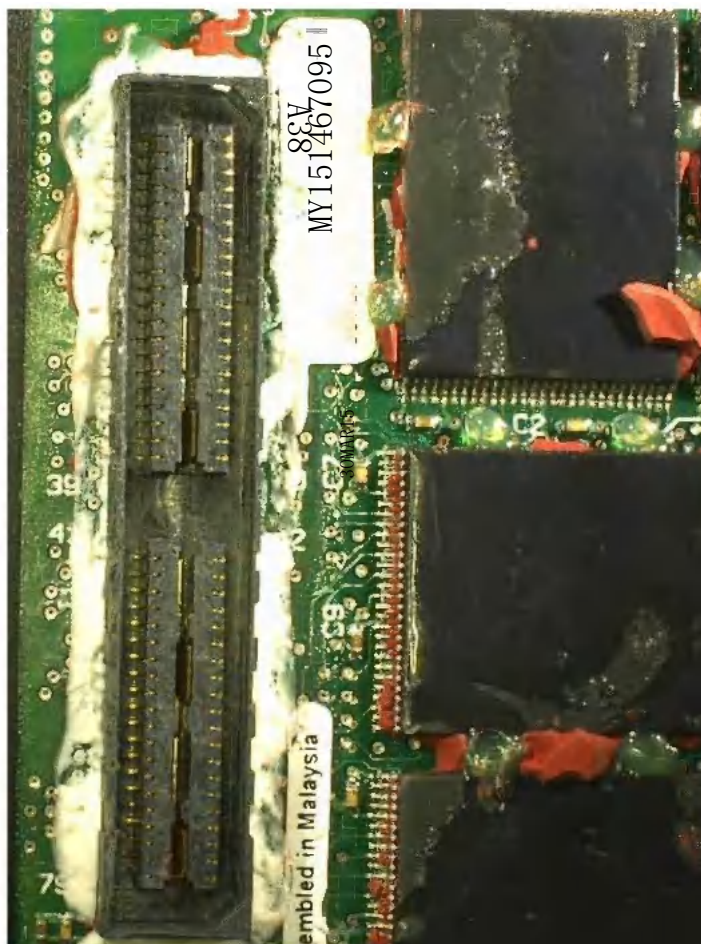
**Figure 3. Detail of CVR memory module connector, as received.**

raised above its normal position, and the pins along that edge were recessed inside the connector housing. In this state it would have been difficult for the male pins on the recovery cable to make a reliable connection with the board. The long edge facing the memory chips was crushed down below its normal position with the pins projecting out notably from the connector housing. It was also found that the ground plane between the two sides of the connector was damaged underneath the connector housing. Several sections of the ground plane were severed or lifted from the board. Figure 3 shows the connector, as received.

该连接器被抬高至超出正常位置，其边缘上的引脚均凹陷在连接器外壳内部。在这种状态下，恢复电缆上的公接头难以与电路板建立稳定连接。面向内存芯片的长边被压低至低于正常位置，引脚明显突出于连接器外壳之外。同时发现连接器两侧之间的接地平面在壳体下方遭到损坏，多个接地平面区域已从电路板上断裂或脱落。图3展示了该连接器的实际状态。

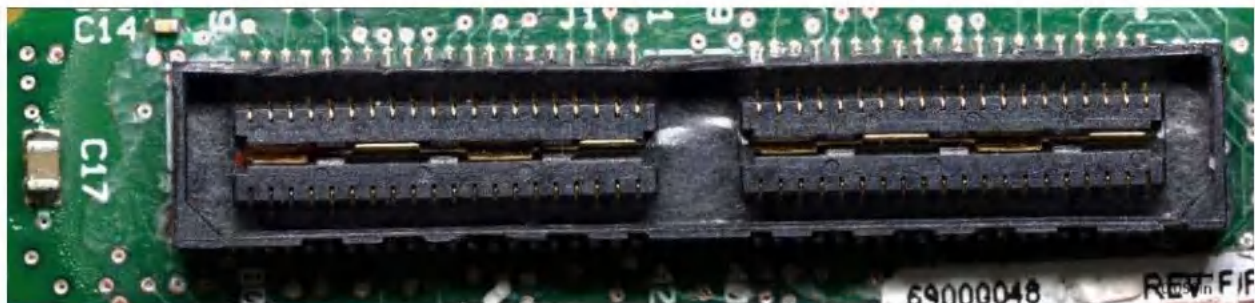
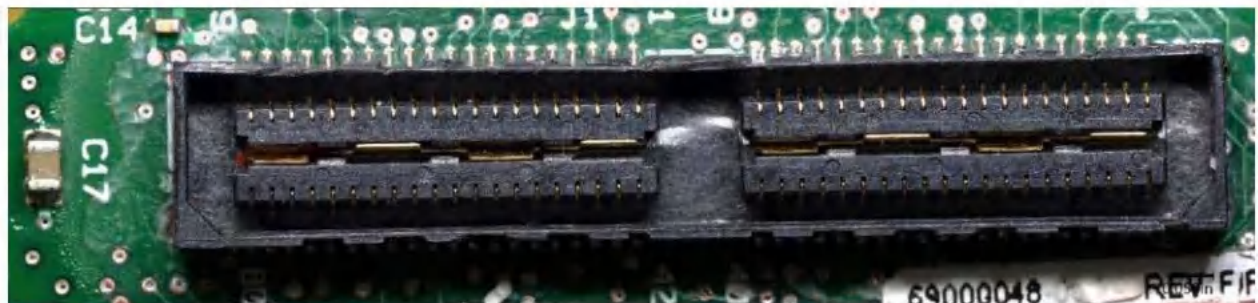
**Figure 4. Connector detail with RTV sealant removed.**

To finalize the preliminary inspections of the board, the remaining RTV sealant on the board was carefully removed from the connector area. All the pins from the connector that were accessible for inspection were physically tested for integrity. (Some pins were not accessible because they were routed under the board.) Numerous loose or separated pins were catalogued. Figure 4 shows the connector prepped for inspection with remaining RTV sealant removed.

The loose and separated pins found in the inspections were repaired using a microscope and a special cyanoacrylate glue. To help make the best connection possible with the damaged board connector, an HFR-5 recovery flex cable was modified to aid in positive connections between the cable and the board. Many of the pins on the cable were bent slightly away from the plastic of the connector, causing them to interface better with the pins that were recessed into the damaged board connector.

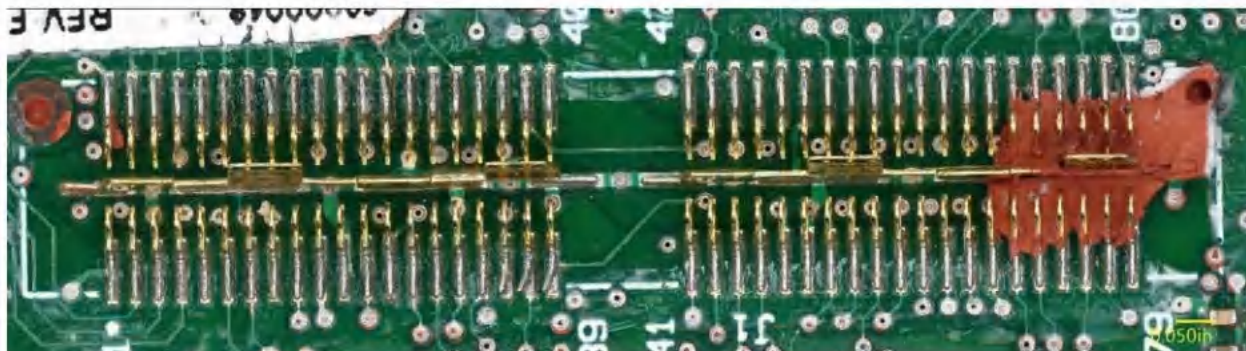
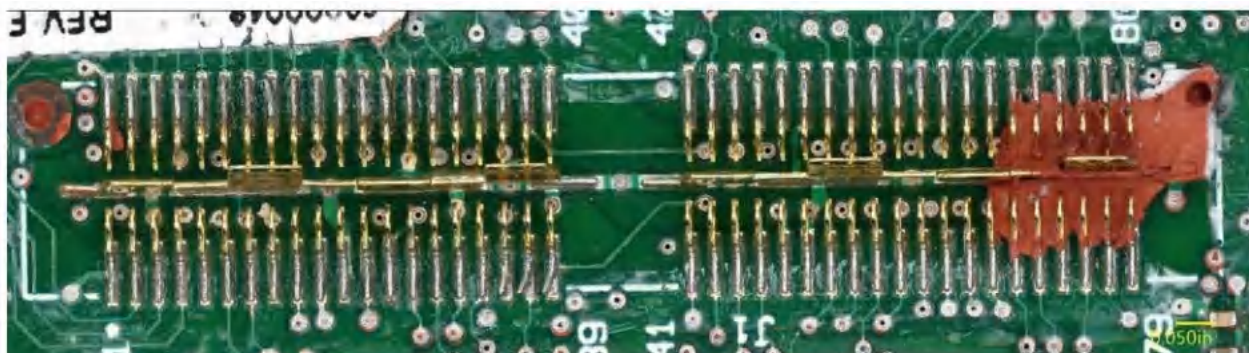
**Figure 5. Detail view of connector pins with shell removed.**

The CVR connector housing was fully removed, which revealed additional damage to the pins that was hidden underneath the plastic. Pins were found pushed down underneath the plastic and numerous additional pads and traces were found to be loose or completely removed from the board. It is likely that the only reason some pins were making contact was that they were pinned down to the board by the connector housing itself. The central ground planes were found to be loose at every attachment point except for one. The memory module with the connector shell removed is shown in Figure 5. Some of the deformations to the pins is shown in Figure 6.

With the downloads only providing poor to fair results and the audio being consistent with damage to chip data and address lines even after attempts to correct the issue, the team determined that the damaged board connector should be removed and possibly replaced. An NTSB surrogate board was identified to be used as a test article to determine the safest process to remove the plastic housing of the connector shell while leaving the pins soldered in place on the board.

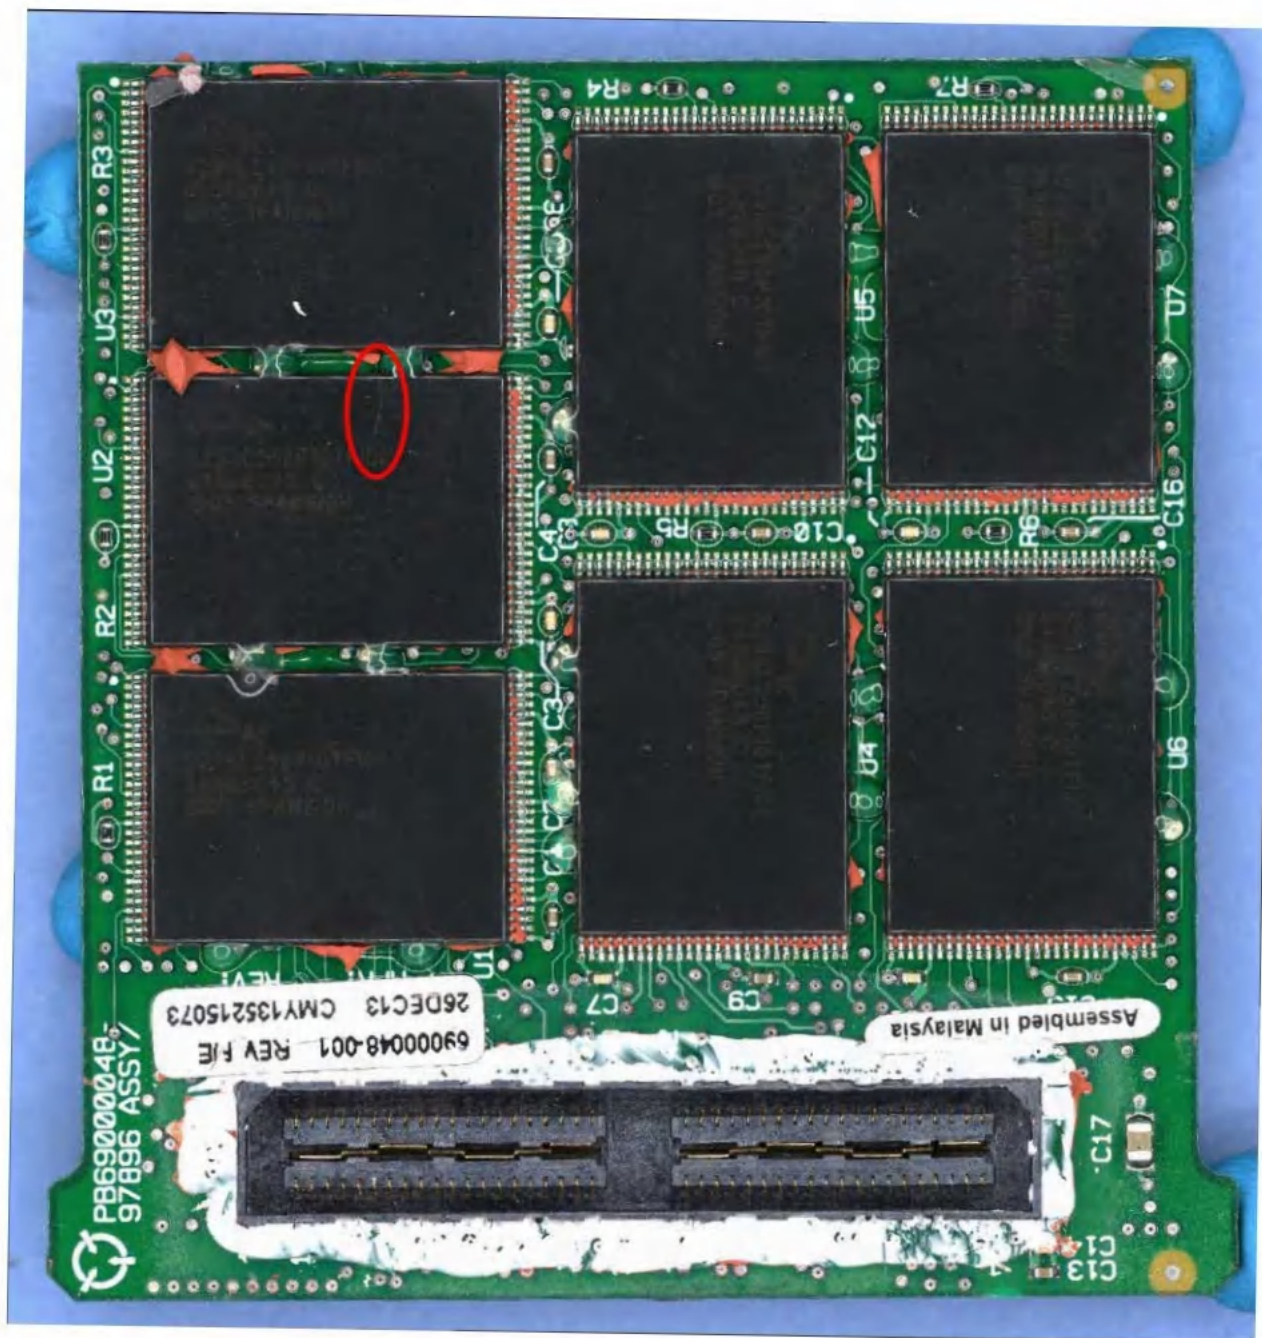
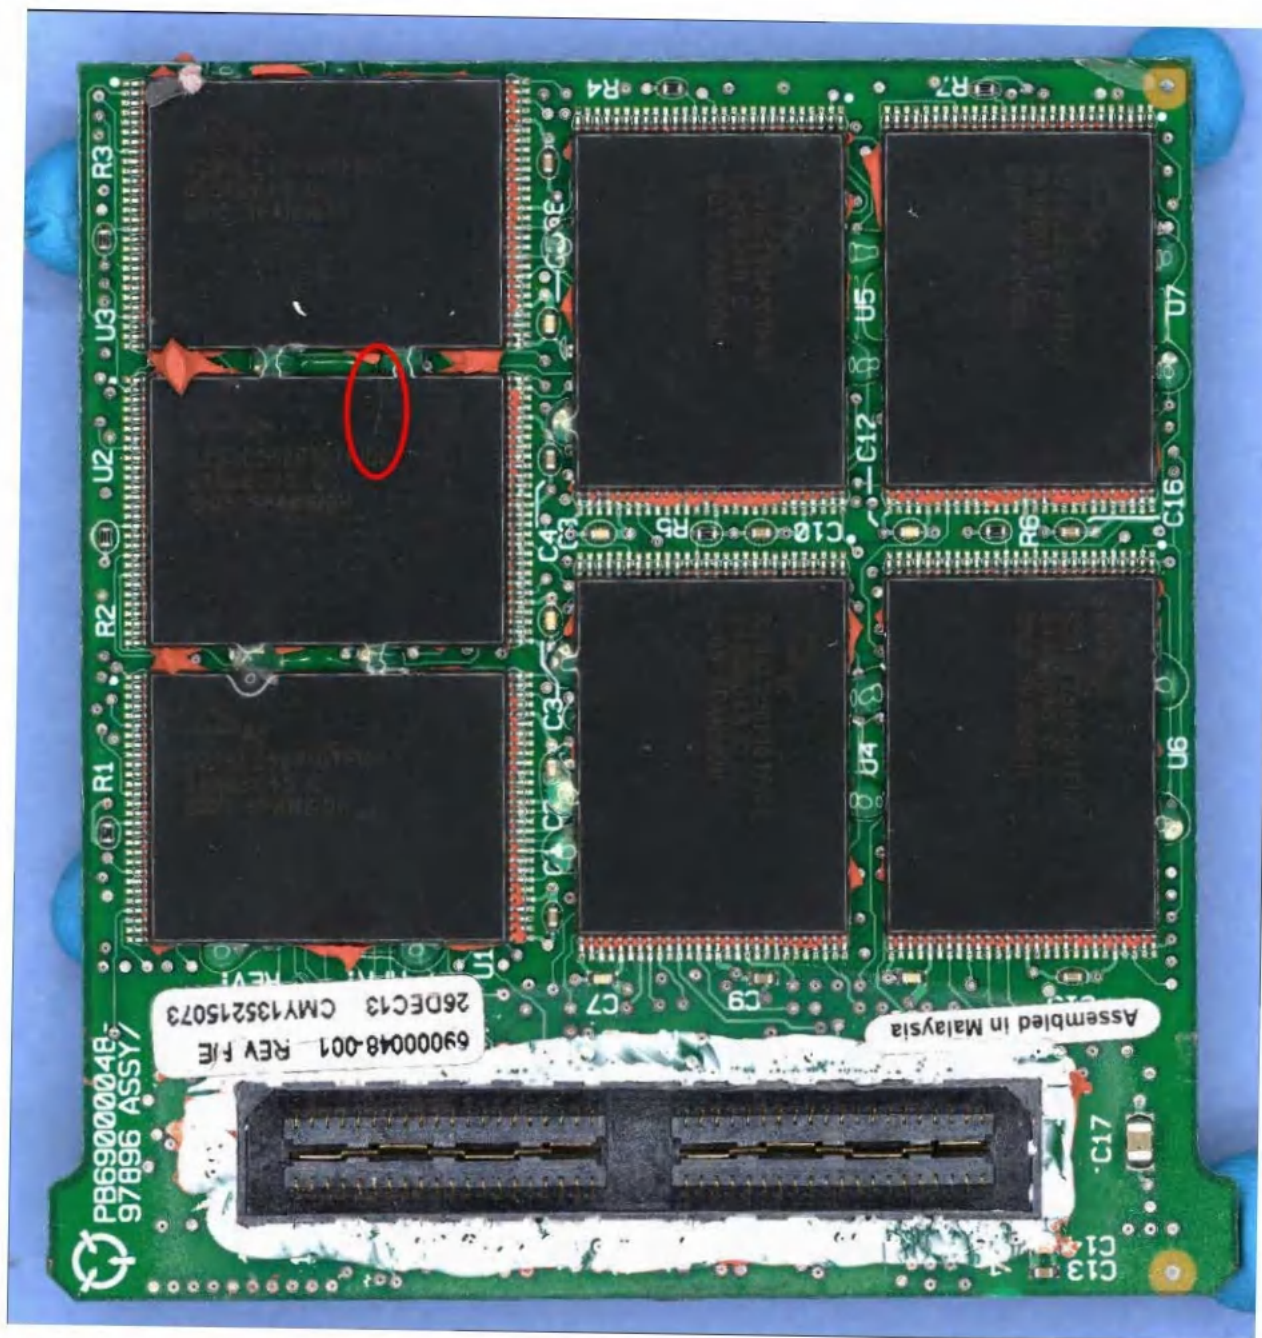
The red RTV was removed from the FDR memory board to allow for an initial visual inspection of the entire module. Figures 7 and 8 show the connector side and opposite side, respectively, of the FDR memory module. The module was inspected under high-power microscopy, revealing that FLASH module number U2 had a crack extending from the top edge of the memory packaging into the center of the chip. The crack penetrated to the surface of the conformal coating over the device. Many of the epoxy balls bonding the chip to the board also showed evidence of cracking and/or separation from the FLASH devices to which they were originally adhered.

Figure 7.Connector side of FDR memory module with crack faintly visible in chip U2.marked with a red circle in the photograph.

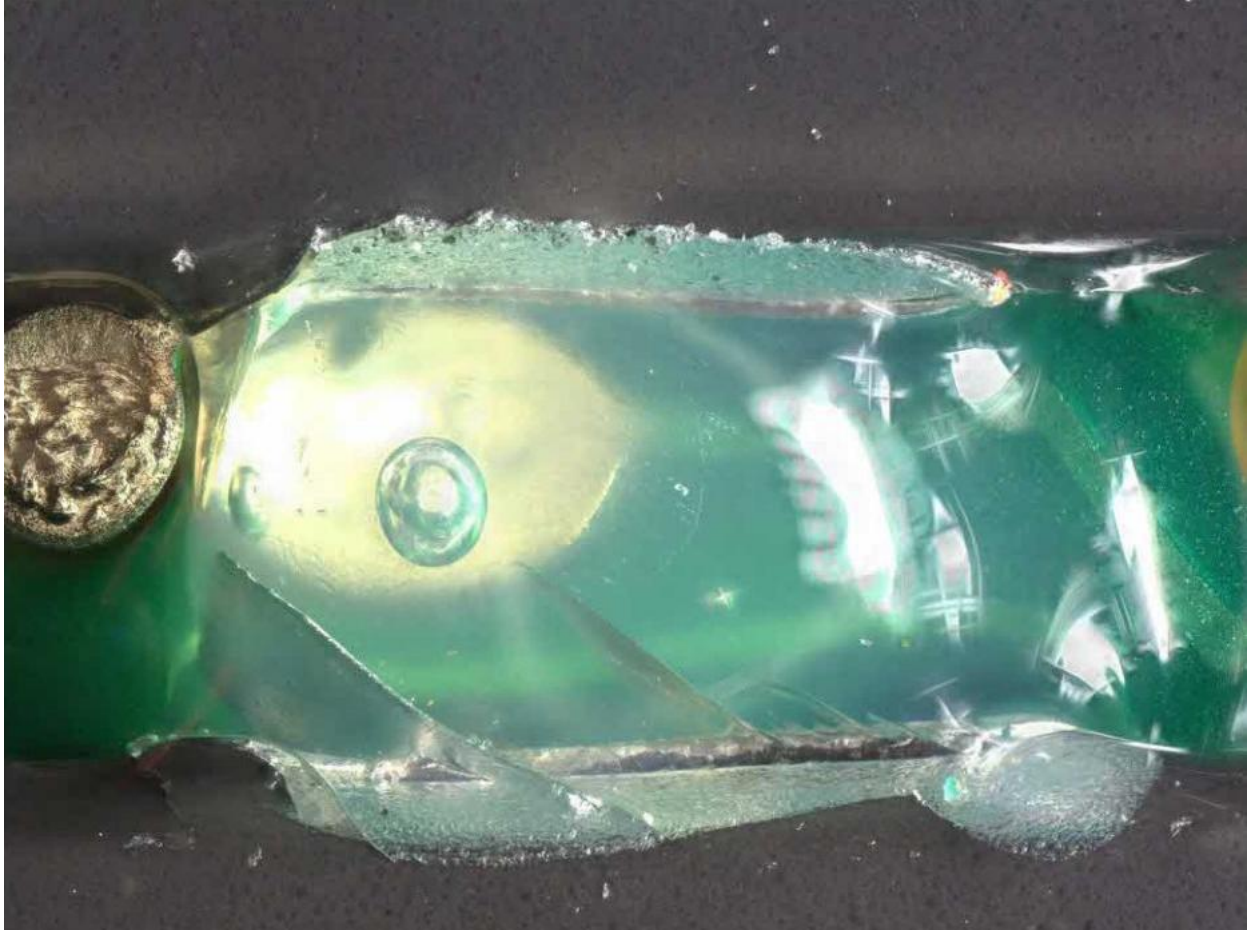
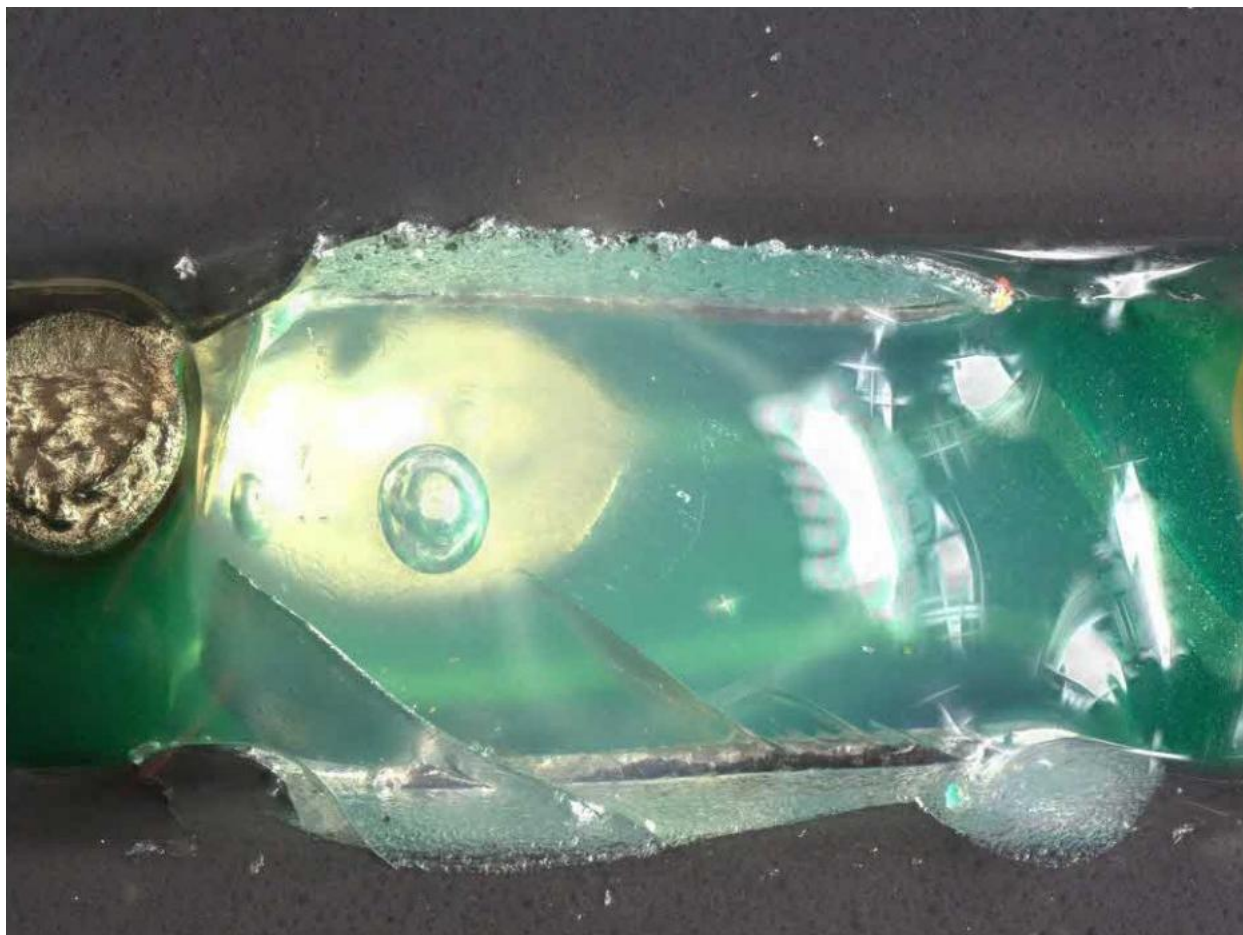
Additional minor cracking was found in the chip packaging areas of many of the epoxy bonds between FLASH modules. This included minor cracking in FLASH module numbers U1&U2, U5&U7, and U51&U52. The majority of the epoxy bonds on both sides of the memory module showed evidence of fractures. Figure 9 shows an example of the cracking seen in the epoxy bond between chips U1 and U2.

**Figure 9.**Example of cracks seen in epoxy bond between chips U1 and U2.

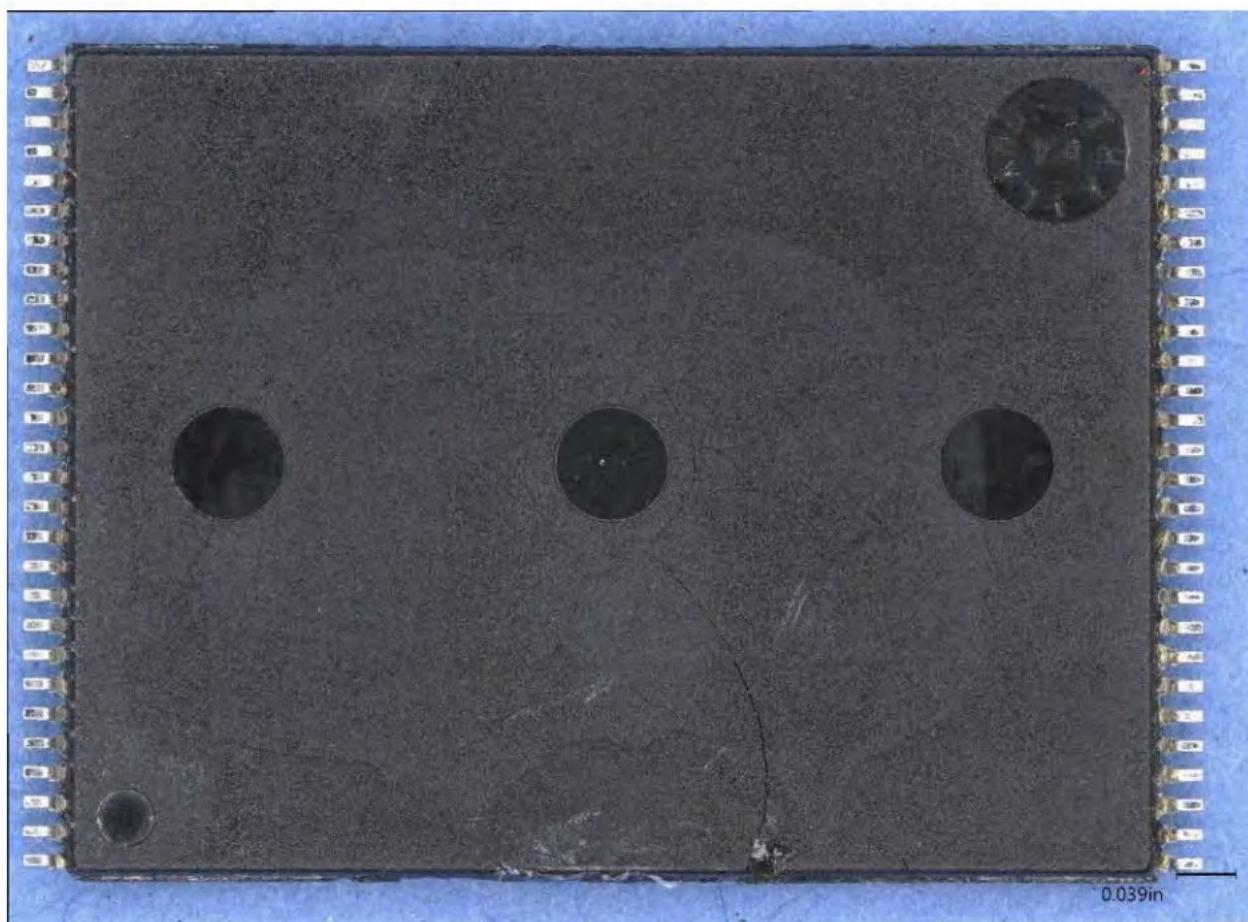
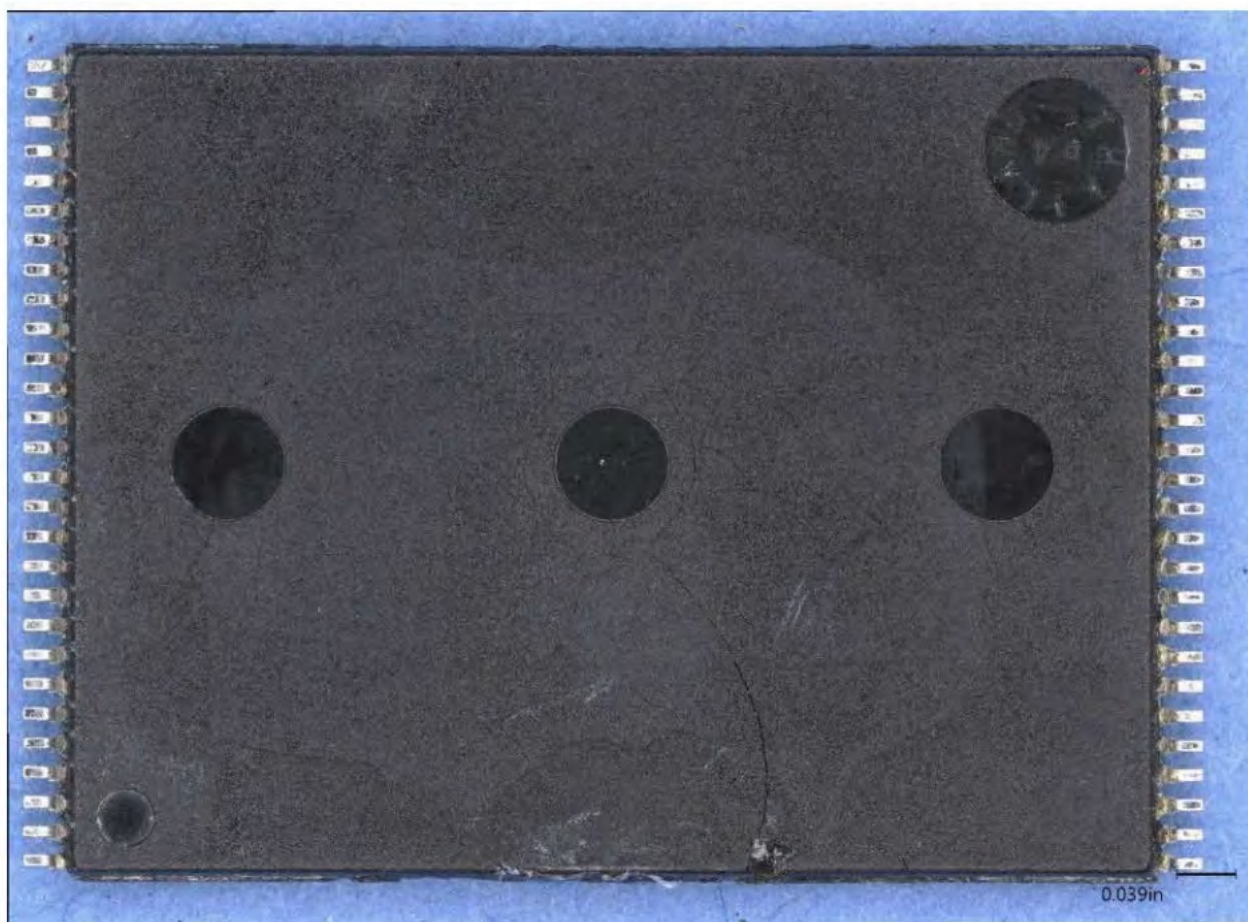
An inspection of chip U2(the chip with the visible crack in the packaging) identified a network of cracks on the bottom of the chip in addition to the previously observed crack.The other chips did not reveal additional damage when they were removed from the board.Figure 10 shows the bottom of chip U2 following removal from the board.

**Figure 10. Bottom side of chip U2 showing cracks throughout chip packaging.**

The chips were read in the Xeltec memory reader and the resulting binary images for chips U1,U3,U4,U5,and U6 were found to contain data. Chip U2 could not be read and the Xeltec reported numerous pin-check errors and messages indicating that many of the pins were shorted. This was a sign of significant internal damage to the silicon die within the chip itself.

Chip U2 was X-rayed and CT scanned, and chip U4 was also X-rayed as an exemplar. The results of the CT scan were noisy and revealed no new information. Some of the cracks identified visually on the bottom side of the packaging were apparent in the 2-DX-ray images. These cracks passed through the region of the chip housing the silicon die containing all the internal circuitry. Several other of the undersurface cracks were not visible in the X-ray because they appeared to follow the outline of the X-shaped copper die pad upon which the silicon die was bonded during manufacture of the chip. This extreme damage rendered any data from U2 unrecoverable.
